FINAL REPORT Monitoring the Effects of Conventional Pile Driving on Three Species of Fish

For:
Manson Construction Company
200 Cutting Blvd.
Richmond CA 94804

April 8, 2005

Monitoring the Effects of Conventional Pile Driving on Three Species of Fish

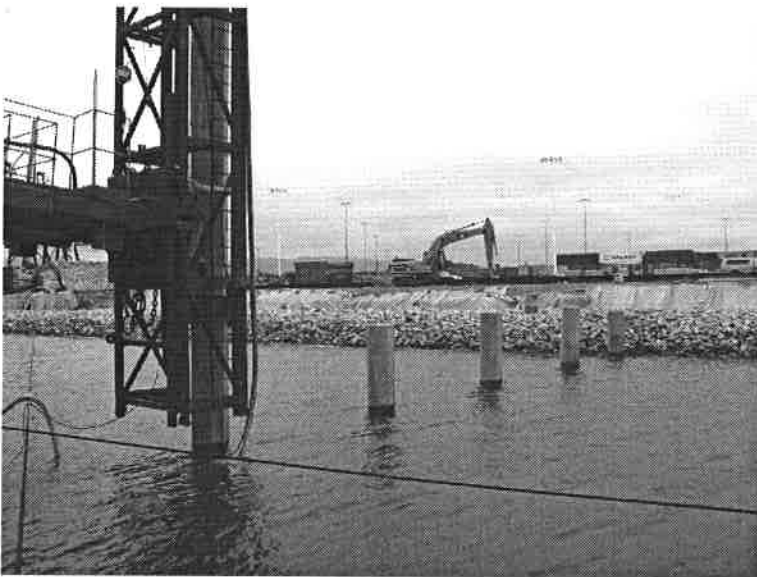
The piles driven during this project were octagonal, steel reinforced concrete, 61 cm (2 ft) in diameter and up to 50 m (164 ft) long with a center hole for injecting water at the tip during pile driving. "Jetting" facilitates pile driving in a sandy substrate. Piles for supporting the new Berth 22 wharf were assigned rows with a unique alphanumeric identifier for each pile. See Figure 3. The "F" piles were entirely on shore and the "A" piles were in water approximately 13 m (42 feet) deep at mean lower low water (MLLW). The specific piles used in this study are listed in Table 1. The piles, pile arrangement, hammer and high pressure hose for jetting are shown in Figures 4, 5, and 7

Figure 7. A pile being driven showing the hose used for "jetting".

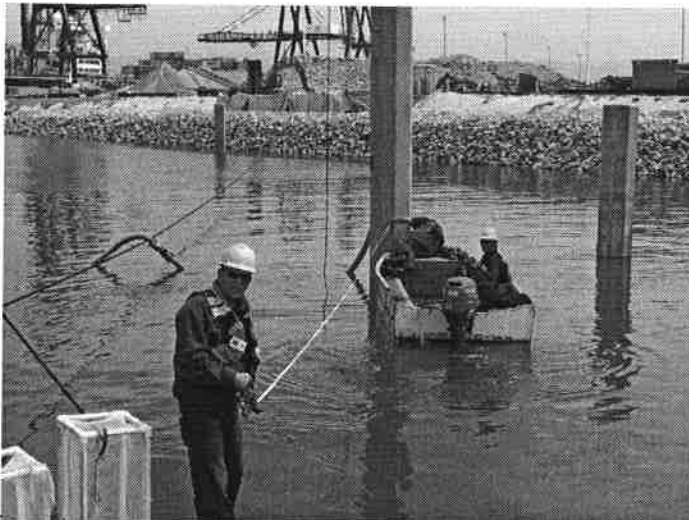
Figure 8. Measuring the distance from the pile to the cage.

A floating work platform was positioned 10 meters from the pile and three anchor lines were lowered to the bottom to hold the cages in position irrespective of the tidal currents. See Figure 9. Before pile driving started, a technician lowered one of the fish cages half way into the water, keeping the open end up; the bag of fish were lowered into the cage and upended pouring the fish into the cage water. The end of the cage net was tied off with a quick release slipknot, and the cage was lowered to the pre-determined depth of 8 meters and held in place by a tether line.

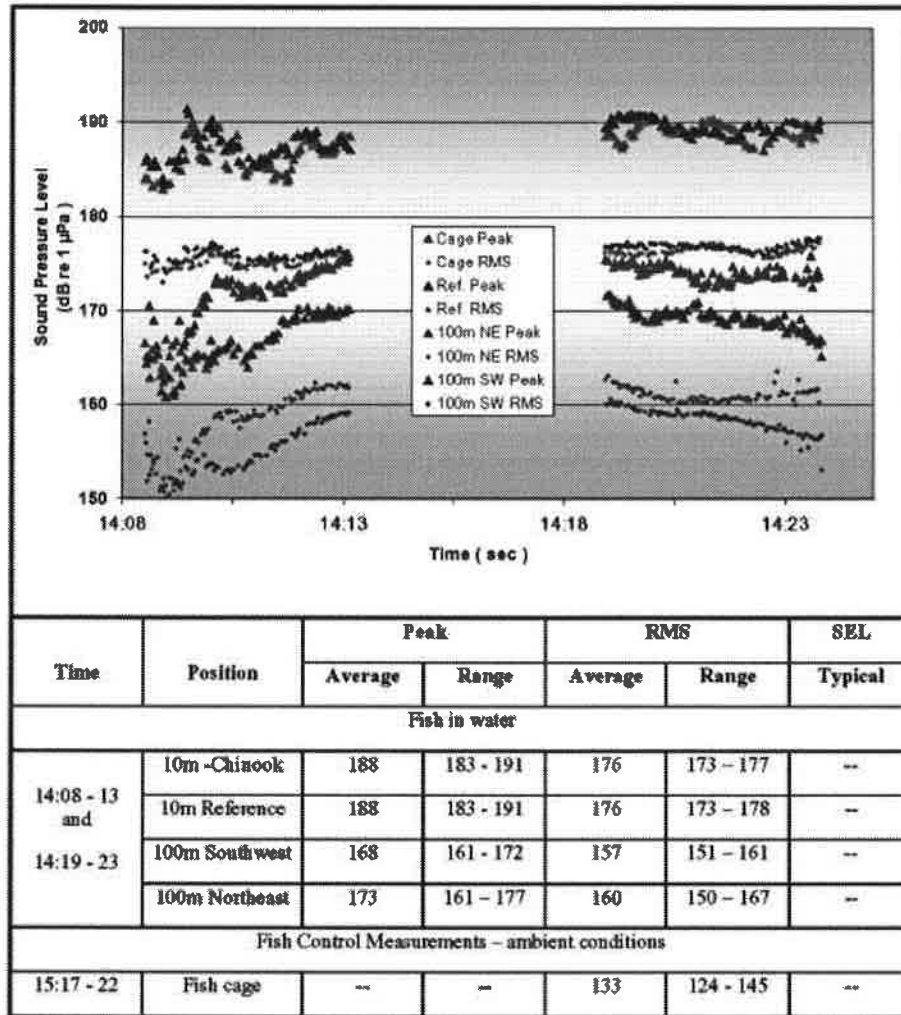
The first set of measurements and fish exposures to pile driving sounds were conducted on August 2, 2004 when Pile 277B was driven. Measurements were made at 10-m from the pile in one of the three cages containing fish. Measurements were also made at a reference position outside of the cage (at 10-m from the pile), an unattended position 100-m northeast of the pile, and an unattended position 100-m southwest of the pile. All hydrophones were positioned at a depth of about 8-m, where water depths were about 10-m to 13-m deep. The DAT recorder for the 10-m fish cage and reference position failed; and therefore, recordings at 10-m from the pile were not made. Continuous SLM measurements were successfully made at all positions. Ambient conditions were measured after pile driving when “control” fish were placed in the water near the pile. Results are shown in Figure 12.

Figure 12. Measured Sound Pressure Levels for Pile 277B (reported in dB re 1 µPa).

During the entire driving period, sound pressure levels at 10m from the pile ranged from 183 dB re 1 μ Pa Peak (170 dB re 1 μ Pa RMS) to 192 dB re 1 μ Pa Peak (177 dB re 1 μ Pa RMS). The SEL was about 166 dB re 1 μ Pa. During the period when fish were exposed (for the first 3 to 4 minutes of the nearly 25-minute drive), average sound pressure levels were 188 dB re 1 μ Pa Peak, 176 dB re 1 μ Pa RMS and about 167 dB re 1 μ Pa SEL. Average sound pressure levels at 100m southwest were 174 dB re 1 μ Pa Peak, 162 dB RMS and about 152 dB re 1 μ Pa SEL. Sound pressure levels were highest near the beginning and end of the drive. Sound pressure levels were about 14 dB re 1 μ Pa lower at 100m southwest than at 10m from the pile.

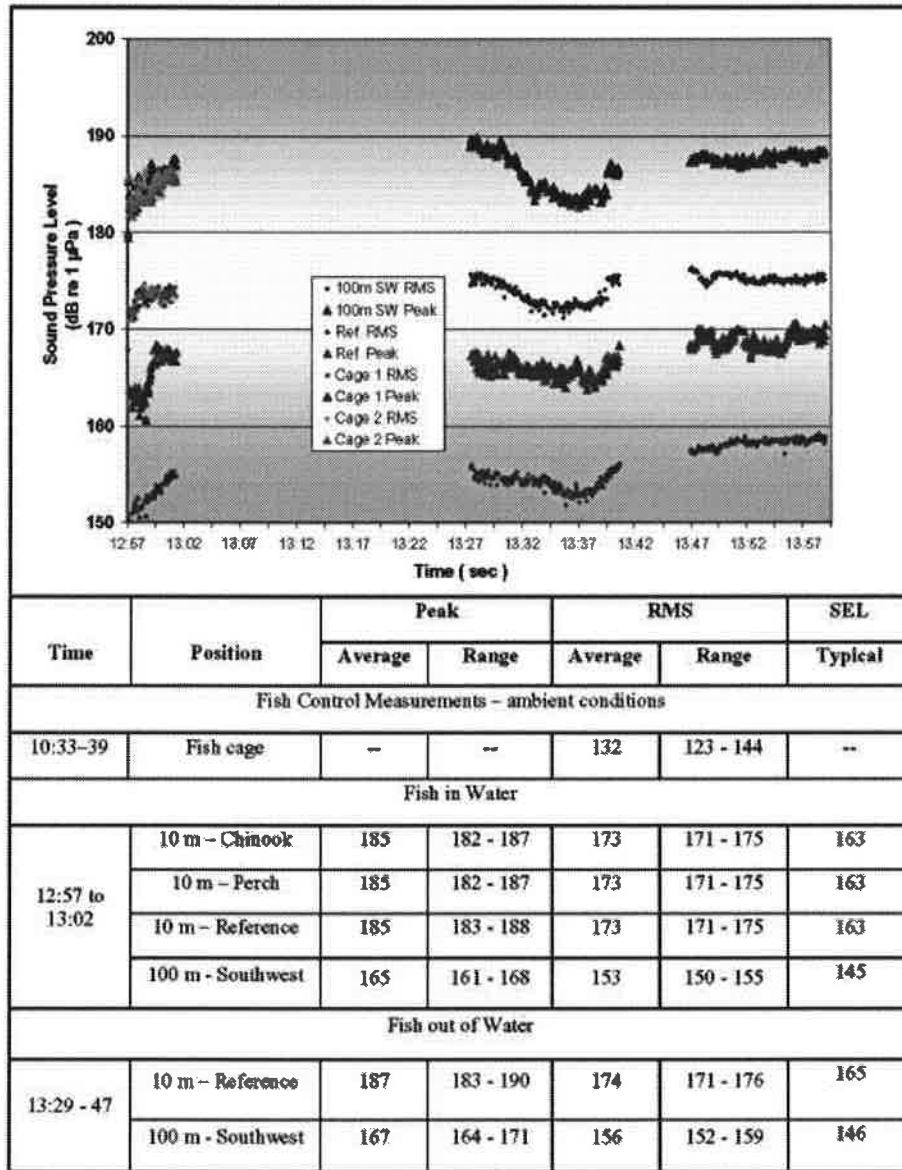
Figure 13. Measured sound pressure levels for pile 277 A.

Pile 277A was driven during the early afternoon of August 3, 2004. Measurements were made inside two of the fish cages, at a reference position outside the cage, and at the 100m southwest position from the dock. Fish were exposed to approximately 200 impulses (approximately 3 minutes of driving). Pile driving was suspended until all fish had been removed from the water. Underwater sound measurements continued at the reference positions (10-m from the pile) and at the 100-m distant position when pile driving resumed. Ambient conditions were measured in the morning when control fish were placed in the water near the dock prior to pile driving. Results are shown in Figure 13.

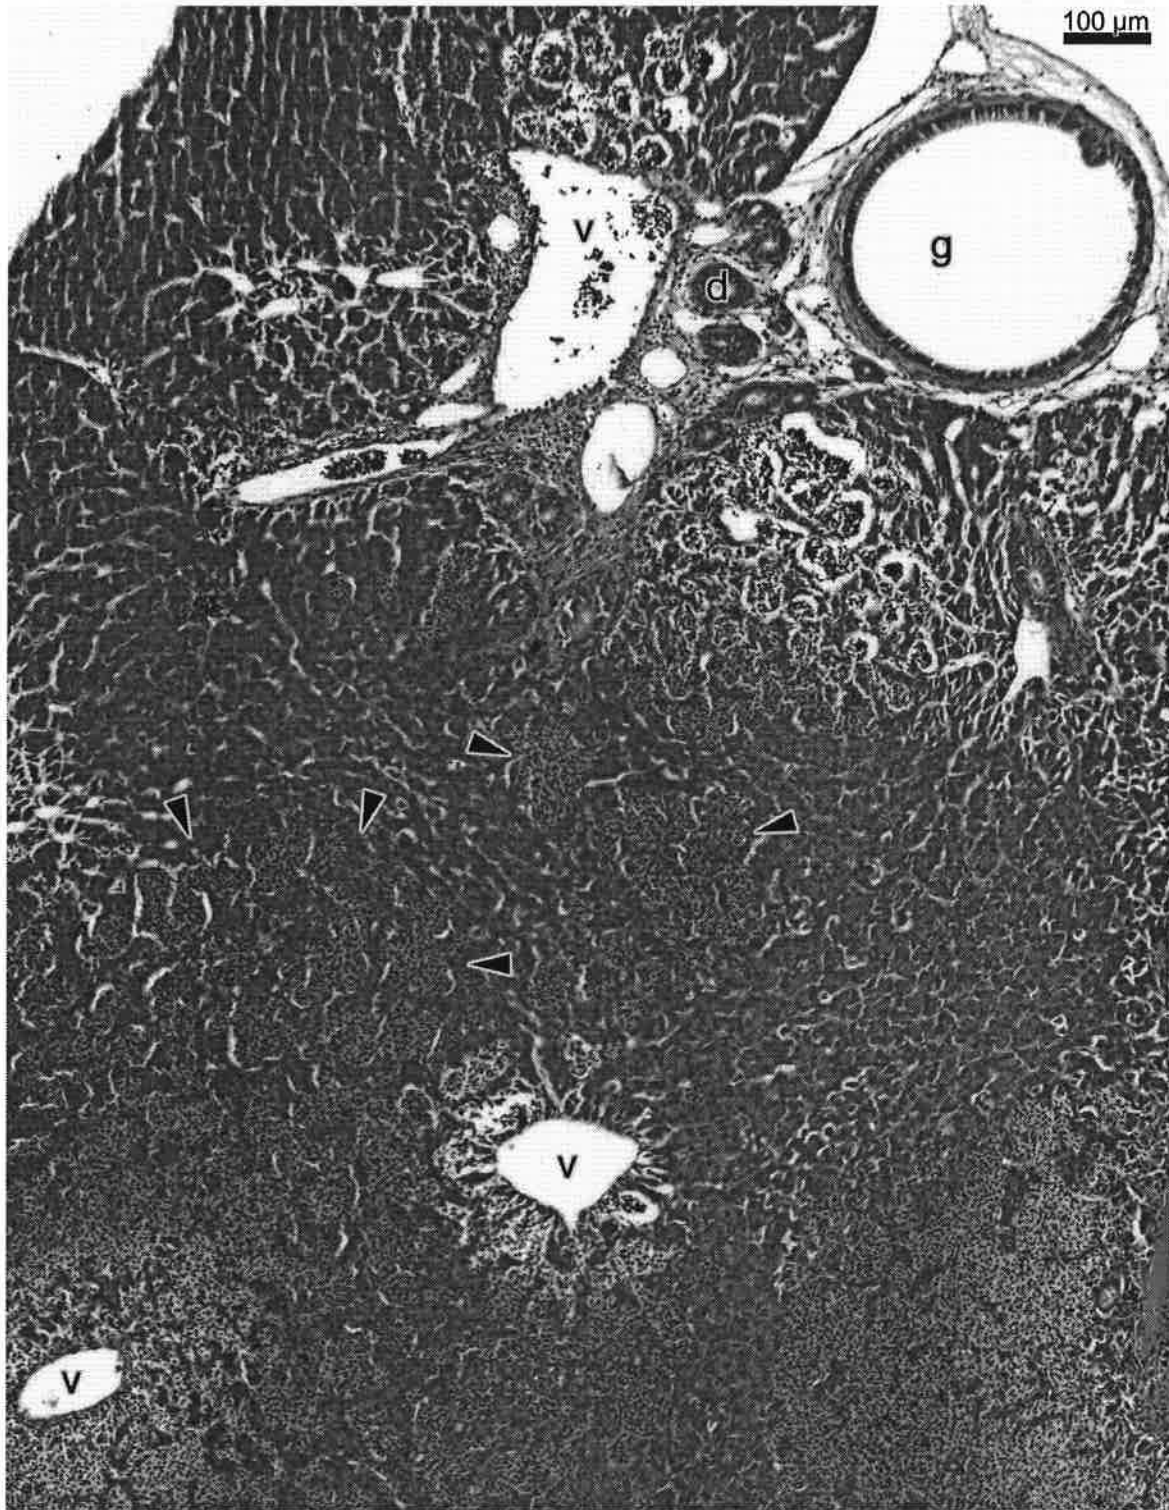
Figure 2. Hemorrhage (arrowheads) in Chinook salmon liver (04POS-22, control fish). Gallbladder (g), bile ductule (d), and blood vessel (v).

One chinook salmon had hemorrhage in the liver (04POS-22, a control fish) that was described grossly as "7, 1-mm-diameter red foci on the liver." Sections of normal livers had small numbers of erythrocytes (= red blood cells) within blood vessels (Figure C-2), but the affected liver had distended and ruptured capillaries (= sinusoids) filled by abundant erythrocytes (Figure C-2). No northern anchovy or shiner perch had hemorrhage in the liver.

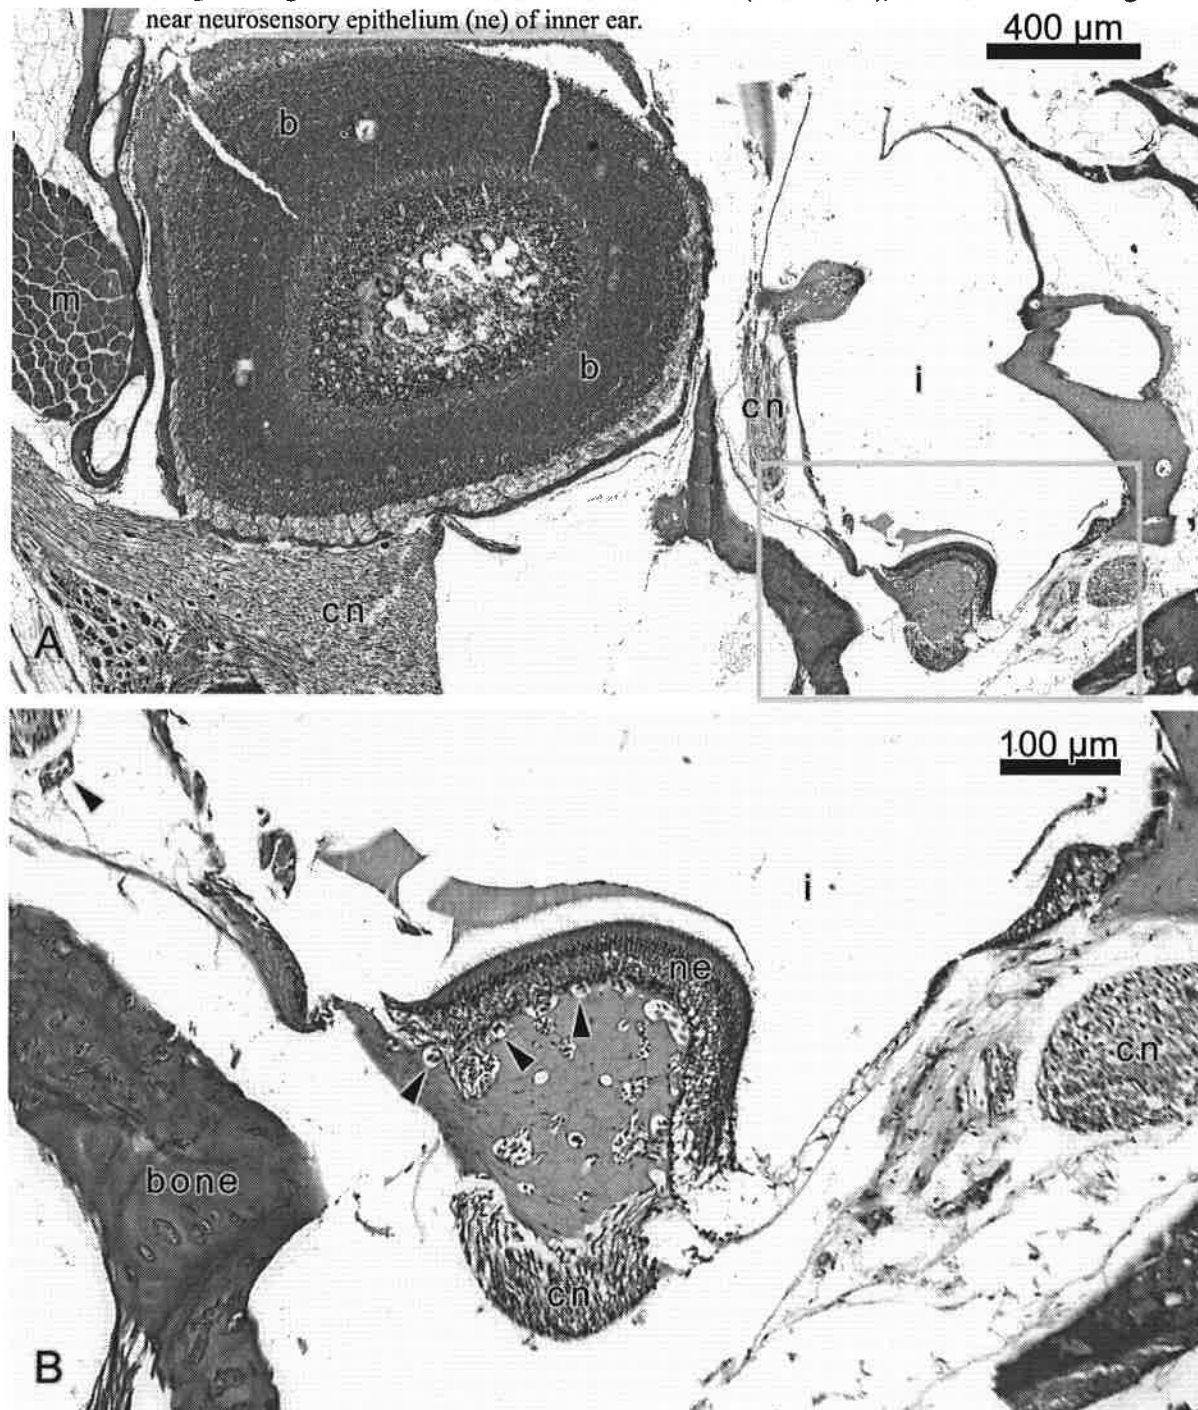
Figure 5. Section of brain (b) and surrounding inner ear (i), cranial nerves (cn), skeletal muscle (m), and bone of a northern anchovy (04POA-20, control fish). Yellow box in A outlines area shown at higher magnification in B. Note intact blood vessels (arrowheads), and lack of hemorrhage near neurosensory epithelium (ne) of inner ear.

Hemorrhage in the brain or inner ear occurred in two of the 19 northern anchovies examined, and both were control fish. Both affected fish died before the necropsy began, and neither fish had gross lesions more severe than mild focal skin reddening in one of the two affected fish. Sections of the normal brain had small to moderate numbers of erythrocytes in the blood vessels around the brain, and the lumen of the semicircular canals of the inner ear were free of erythrocytes (Figure C-5). In fish with hemorrhage, erythrocytes surrounded cranial nerves at the base of the brain and partly filled the semicircular canals (Figure C-6).

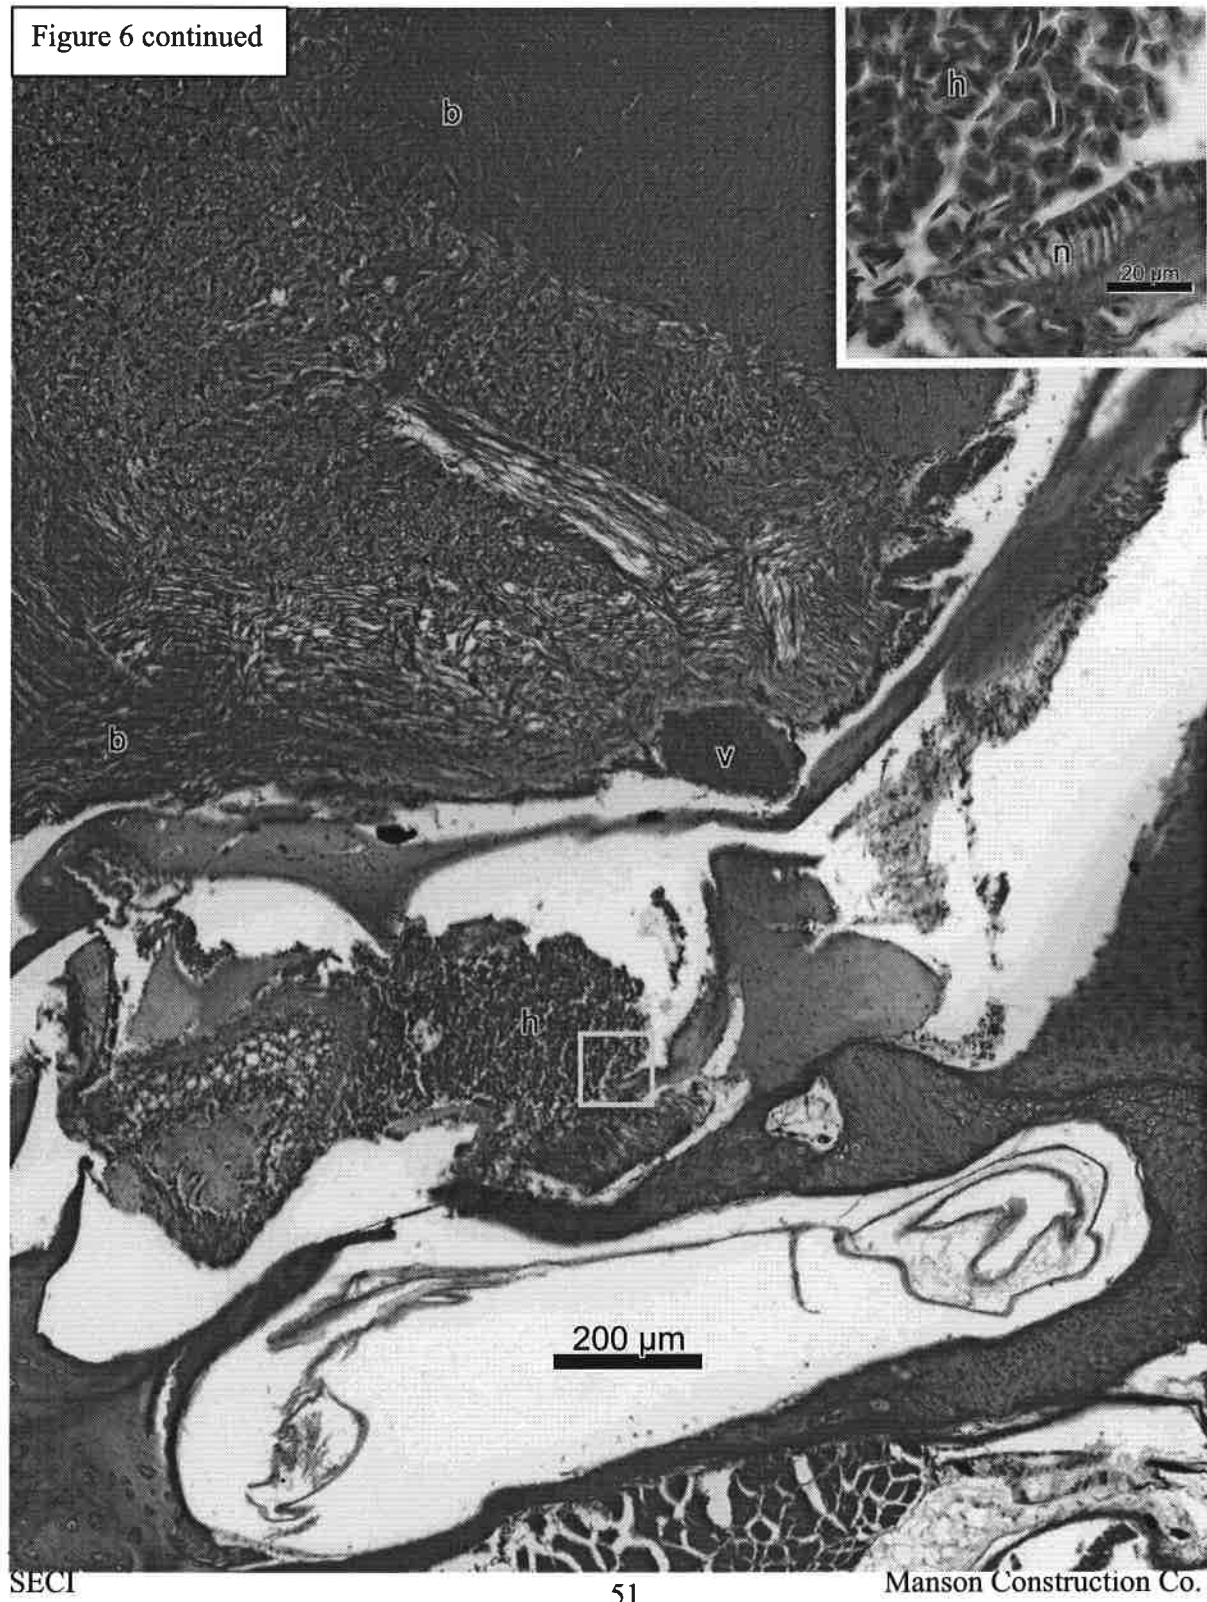
Figure 6 (facing pages). Hemorrhage (h) on the ventral margin of brain (b) and in inner ear of a northern anchovy (04POA-16, control fish). Intact blood vessel (v), and neurosensory epithelium (n) of inner ear (inset). Yellow box outlines area shown at higher magnification in inset.

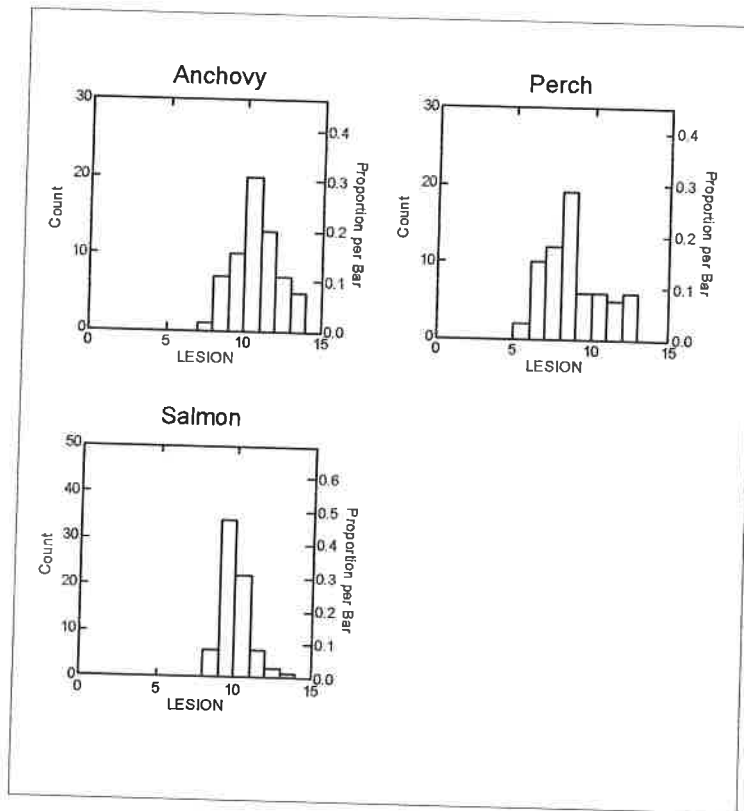
Figure D-1. Frequency distribution plots of the summed variable LESION for each of the three species.

Dr. Marty scored nine gross necropsy conditions and some 23 histological lesions from liver, kidney, intestine, and various other tissues for each fish. In Appendix C, the data are presented essentially as two treatment groups (hammer/control) with a mean and overall (naïve) standard error for each treatment, i.e., ignoring the grouping into cages. In that useful summary, treatment means are seen generally to differ by a small amount compared to their standard errors, even though the tabulated standard errors are about half as large as they should be (if calculated for each cage of fish). For the formal analysis presented here, scores for 23 histological lesions were summed to form a single response variable, called LESION. This variable was less skewed than the original variables and, though not normal, at least approached symmetry (Figure D-1). The mean LESION score is given for each species in each cage in Table D-2.

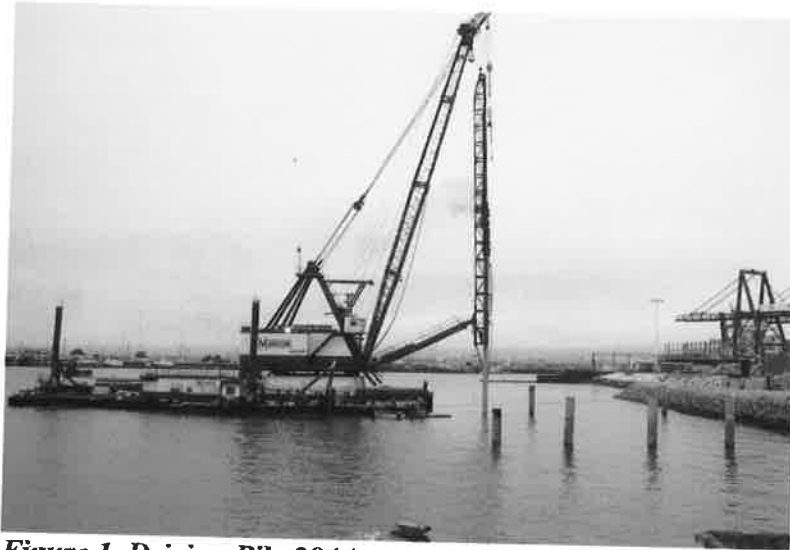
Figure 1. Driving Pile 284A.

Pile driving was conducted using a model D62-22 Delmag diesel pile hammer. The hammer operates as a large piston (13,000 lbs) in a diesel combustion engine generating up to 224 kilo joules (165,000 foot lbs) of energy on each blow. There are several features that protect the pile and equipment, most notably the cushion block, which consists of laminated plywood that is about 1/3rd of a meter thick and separates the “pill” of the pile hammer and the pile. This “softens the blow” from the hammer to the pile, as the hammer does not directly strike the concrete pile.
